## 2-D Electrical Resistivity Imaging of Bedrock Fissures in Oru, South-West Nigeria: Implications to Stability Integrity for Proposed Engineering Structures

*Sakirudeen Akinola Ishola*

*Department of Earth Sciences, Olabisi Onabanjo University Ago-Iwoye, P.M.B 2002, Ago-Iwoye, Ogun State, Nigeria*

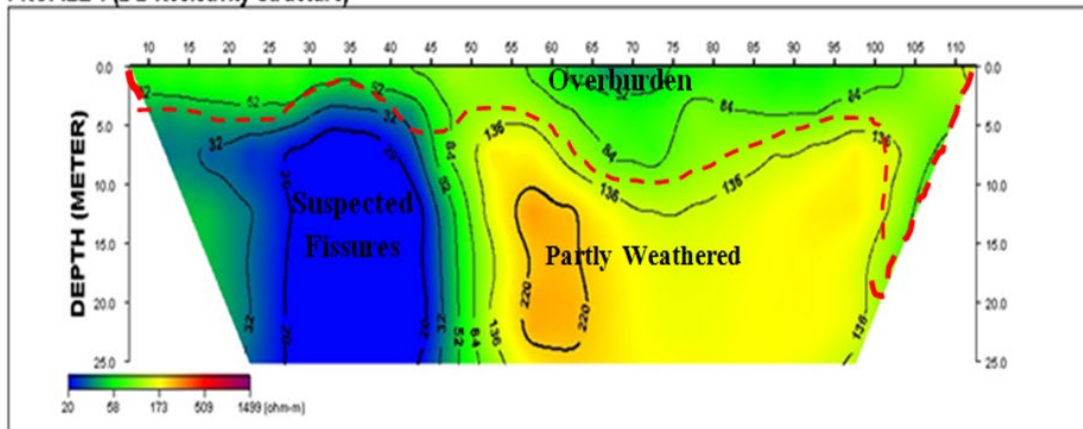
PROFILE 1 (2-D Resistivity Structure)

Image Traverse Line 1: The 2D resistivity sections beneath traverse 1 reveal overburden with resistivity ranging from 20 to 76.6  $\Omega\text{m}$  and thickness varying from 3 m to 7 m. The exhibited low resistivity values represent the bedrock underlying the extreme southwest portion of the traverse, which appears to be partly weathered with resistivity of 220  $\Omega\text{m}$  at a lateral distance of 50 to 102 m. The low resistivity zone of 20  $\Omega\text{m}$  observed at a lateral distance of 20 to 42m are suspected to be bedrock fissures found beneath 4m and extended to 25m in depth (Figure 5).

Figure 5. Oru 2-D profile 1 showing the 2D resistivity section beneath traverse 1.

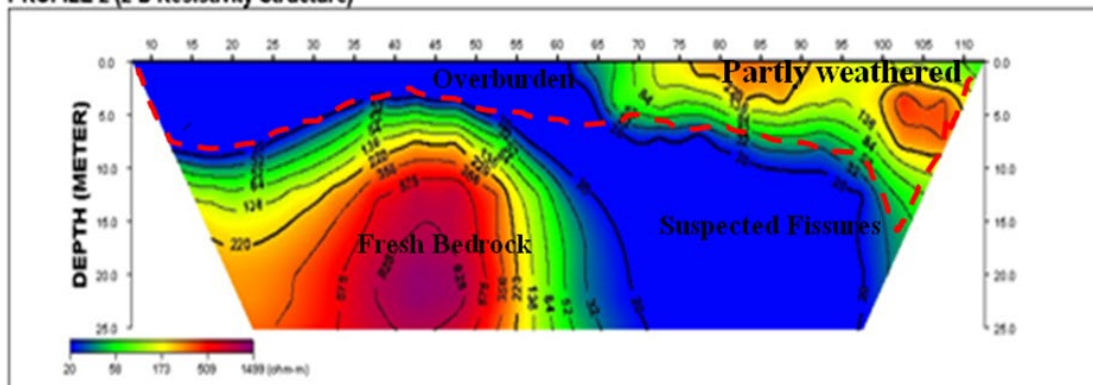
PROFILE 2 (2-D Resistivity Structure)

Image Traverse Line 2: The 2D resistivity section beneath traverse 2 is underlain by a thick overburden that ranged from 4 m to 15 m with resistivity ranging from 20 to 135  $\Omega\text{m}$ . The exhibited very low resistivity zone was delineated at a lateral distance of 0 to 63m from the surface to a depth of 9 m, representing clay and clayey sand. Underlying the extreme southwest portion of the traverse is a relatively resistive overburden of about 15m thick with resistivity of 84 to 345  $\Omega\text{m}$ , which appears to be partly weathered at a lateral distance of 48 to 115 m. The low resistivity zone around 20 $\Omega\text{m}$  observed at a lateral distance of 65 to 95 m are suspected to be bedrock fissures found beneath 10m and extended to 25 m in depth (Figure 6). The resistivity of the fresh bedrock ranged from 1001 to 1499  $\Omega\text{m}$ . The more resistive overburden must have been propelled by the suspected fissures of bedrock occurring within the delineated interval [74-75].

Figure 6. Oru 2-D profile 2 showing the 2D resistivity section beneath traverse 1.

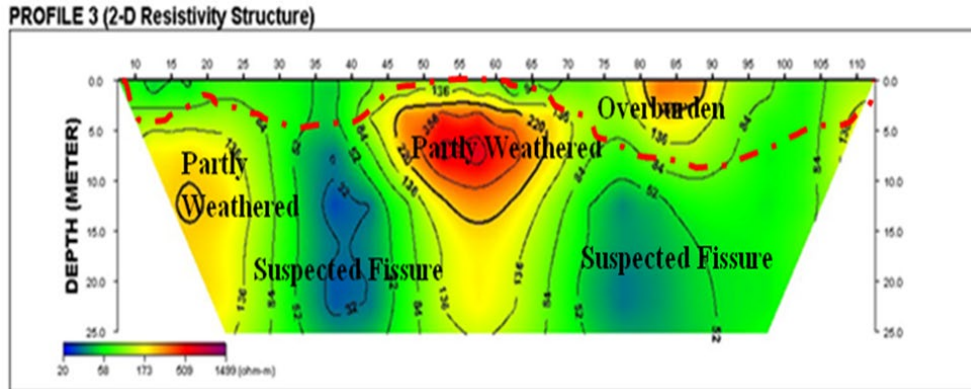
Image Traverse Line 3: The 2D resistivity sections beneath traverse 3 possess an overburden of resistivity value range of 23 to 341  $\Omega\text{m}$  and thickness varying from 2 m to 10 m suggestive of clayey sand mixtures. The bedrocks underlying this layer were partly weathered with resistivity of 135 to 625  $\Omega\text{m}$  at lateral distances of 0 to 25m, 43 to 68 m and 78 to 92 m at corresponding depths of 25, 25 and 6 m, respectively. Two lower-resistivity zones were observed at lateral distances of 30 to 40 m and 70 to 85 m, and were delineated as weak zones. These weak zones were suspected to be of bedrock fissures beneath 10m and extended to the end of the section (Figure 7).

Figure 7. Oru 2-D profile 3.

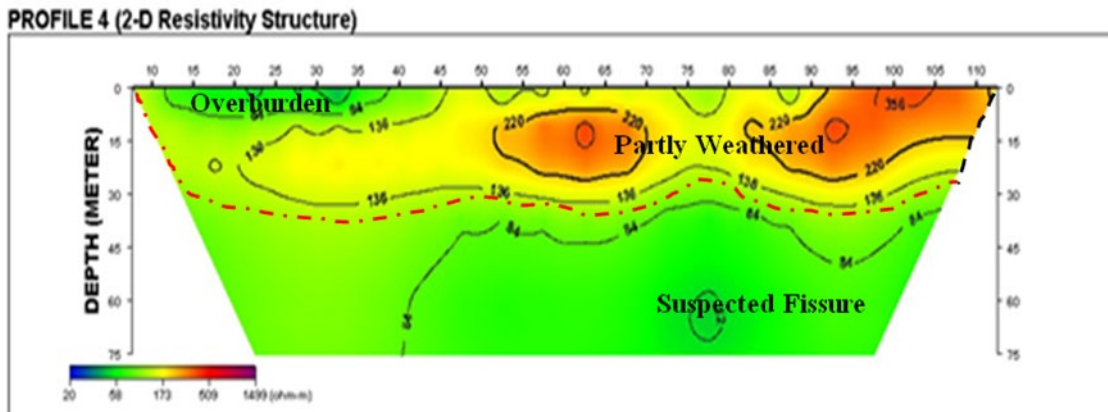
Image Traverse Line 4: The 2D resistivity section beneath traverse 4 is underlain by a thick overburden of about 6 m with resistivity ranging from 50 to 84  $\Omega\text{m}$  consisting of clayey sand at a varying lateral distance of 11 to 45 m, 50 to 60 m, 75 to 80 m, and 85 to 90 m. This was underlain by a partially weathered zone of 136 to 420  $\Omega\text{m}$  at a lateral distance of 50 to 70 m, 82 to 115 m to a depth of 27 m with a thickness of 12 m. The exhibited very low resistivity zone was delineated at a lateral distance of 45 m to 115 m from the depth of 45 m to 70 m, suspected be fissures of bedrock occurring within the delineated intervals [48,75].

Figure 8. Oru 2-D profile 4.

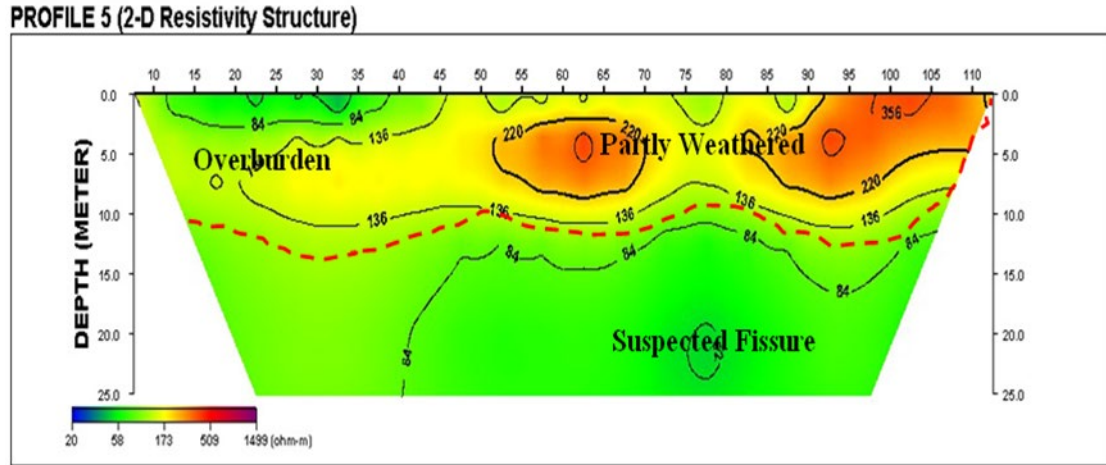
Image Traverse Line 5: The 2D resistivity section was very similar to traverse 4; underlain by an overburden of about 4 m with resistivity ranging from 38 to 93  $\Omega\text{m}$  consisting of a clayey sand mixture at a varying lateral distance of 11 to 44 m, 50 to 57 m, 73 to 80 m, and 85 to 88 m. This was also underlain by a partially weathered zone of 136 to 356  $\Omega\text{m}$  at a lateral distance of 50 to 70 m, 82 to 115 m to the depth of 10 m with a maximum thickness of 7 m. The exhibited very low resistivity zone was delineated at a lateral distance of 45 m to 115 m from a depth of 13 m to 25 m, which is suspected to be characterised by a bedrock fissure within the delineation interval in Figure 9.

Figure 9. Oru 2-D profile 5.

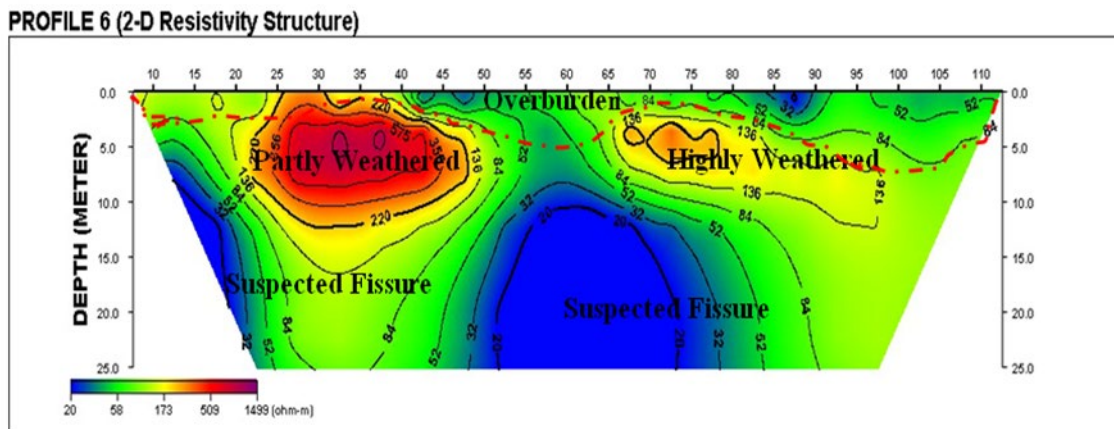
Image Traverse Line 6: The 2D resistivity section beneath traverse 6 at the northeast of the study area underlain by overburden varying from 3 m to 7 m with observed low resistivity 20 to 84  $\Omega$  m consisting of clayey-sand mixture varying lateral distance of 45 to 50 m, 85 to 90 m with the clay exhibiting a lower resistivity of 32  $\Omega$ m with a very thin bed of 1.5 m. This was also underlain by a partially weathered zone with resistivity values of 220 to 575  $\Omega$ m at a lateral distance of 25 to 50 m, while the highly weathered zone exhibited resistivity values of 84 to 136  $\Omega$ m with a maximum thickness of 17 m. The weathered horizon extended to a total depth of 20m. Two separate zones of significantly low resistivity values ( $\leq 20 \Omega$ m) were observed between the partly weathered horizons and were consequently delineated as suspected fissures (Figure 10).

Figure 10. Oru 2-D profile 6.

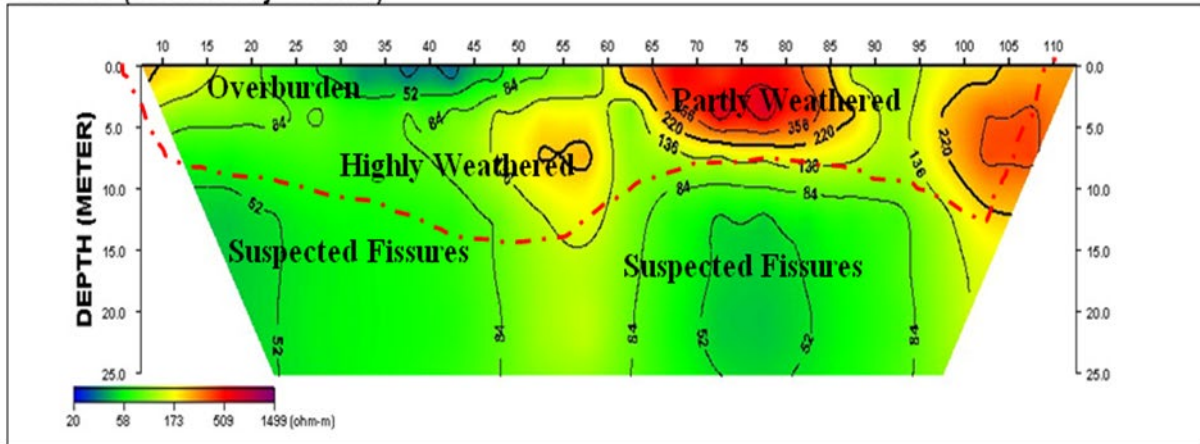
**PROFILE 7 (2-D Resistivity Structure)**

Image Traverse Line 7: The 2D resistivity section beneath traverse 7 was underlain by an overburden of resistivity values ranging from 52 to 84  $\Omega$ m at varying depths of 2 to 8 m.

Clay-sand was found at a near-surface at lateral intervals of 30 to 45 m on a thin overburden around 1.5 m. A partially weathered zone was also delineated within a lateral distance of 65 m to 95 m with a thickness of about 5 m, while a highly weathered zone at a lateral interval of 45 to 60 m was also delineated with continuous extension from the depth of 4 m to 25 m (Figure 11). Between the highly weathered zone and beneath the partly weathered zone, two anomalous zones observable at lateral intervals of 10 to 15 m and 70 to 80 m within the bedrock are suspected to be weak or distressed zones occasioned by fissuring. Also, the more resistive overburden observed as overlying formation rock materials must have been propelled by the suspected fissures of bedrock occurring within the delineated interval [11,48].

Figure 11. Oru 2-D profile 7.

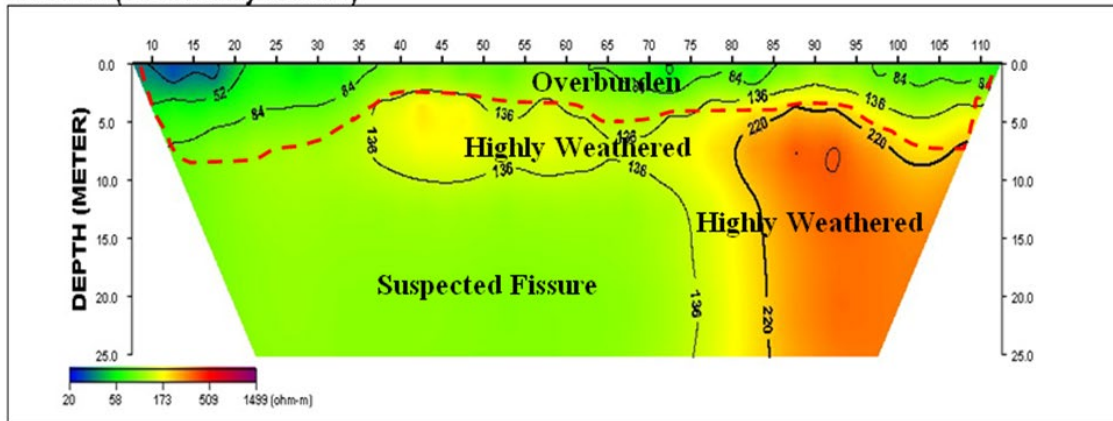
**PROFILE 8 (2-D Resistivity Structure)**

Image Traverse Line 8: The 2D resistivity section beneath traverse 8 was underlain by overburden of resistivity values ranging from 52 to 84  $\Omega\text{m}$  at varying depths of 2 to 9 m. Small portion of clay-sand materials were found at a near-surface at lateral intervals of 0 to 20m on a relatively thin overburden up to the depth of 3 m. Highly weathered zones were delineated within a lateral distance of 37 m with continuous extension throughout the entire length of the section, with accompanied varying thickness of 5 m (depth of 5 m to 10 m), while the extension of the highly weathered zone continuously runs to merge with the fresh bedrock. The delineated low resistivity zone between the distances of 25 m to 66 m was suspected to be weak zones cutting deep into the basement (Figure 12).

Figure 12. Oru 2-D profile 8.

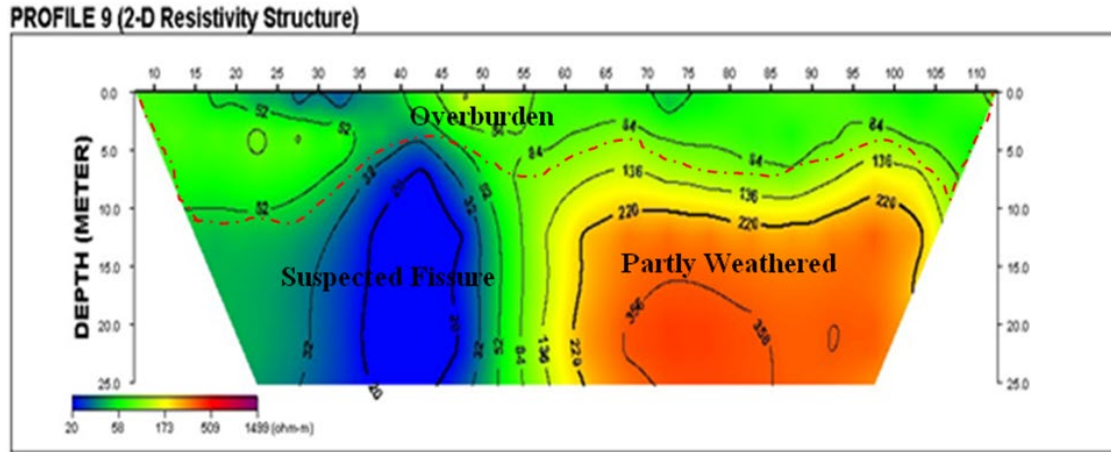
Image Traverse Line 9: The 2D resistivity section beneath traverse 9 was underlain by overburden of resistivity values ranging from 38 to 52  $\Omega\text{m}$  at varying depths of 5 to 12 m. Small portion of Clay-sand materials were found at a near-surface at lateral intervals of 20 to 35 m on a relatively thin overburden up to the depth of 3 m. Partially weathered zone was delineated at a lateral distance of 55 m to 115 m with continuous extension to the end of the section, with a thickness greater than 15 m as the extension of depth of the highly weathered zone merges with the fresh bedrock of the area. The delineated low resistivity zone observed between the lateral distances of 30 m to 47 m was suspected to be a weak zone that emerged from a depth of 5 m and continuously moved into the basement depth into the basement (Figure 13).

Figure 13. Oru 2-D profile 9 .

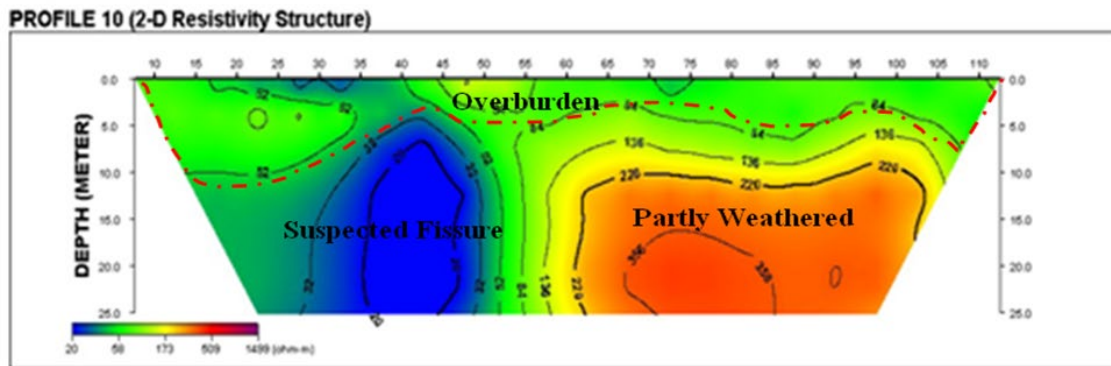
Image Traverse Line 10: The 2D resistivity section beneath traverse 10 was underlain by an overburden of resistivity value range of 52 to 84  $\Omega\text{m}$  at varying depths, with minimum and maximum thickness of 2 and 11 m, respectively. Partially weathered zone was delineated at a lateral distance of 60 m to 115 m with continuous extension to the end of the section, with a thickness greater than 17 m as the extension of depth of the highly weathered zone merges with the fresh bedrock of the area. The delineated low resistivity zone observed between the lateral distances of 30 m to 50 m was suspected to be a weak zone that emerged from the depth of 5 m and continued deeply into the fresh bedrock (Figure 14).

Figure 14. Oru 2-D profile 10.
